Guidance and Lessons Learned from Monitoring Completed Navigation Projects

Compiled by Lyndell Z. Hales and Donna L. Richey

June 2004

Final report

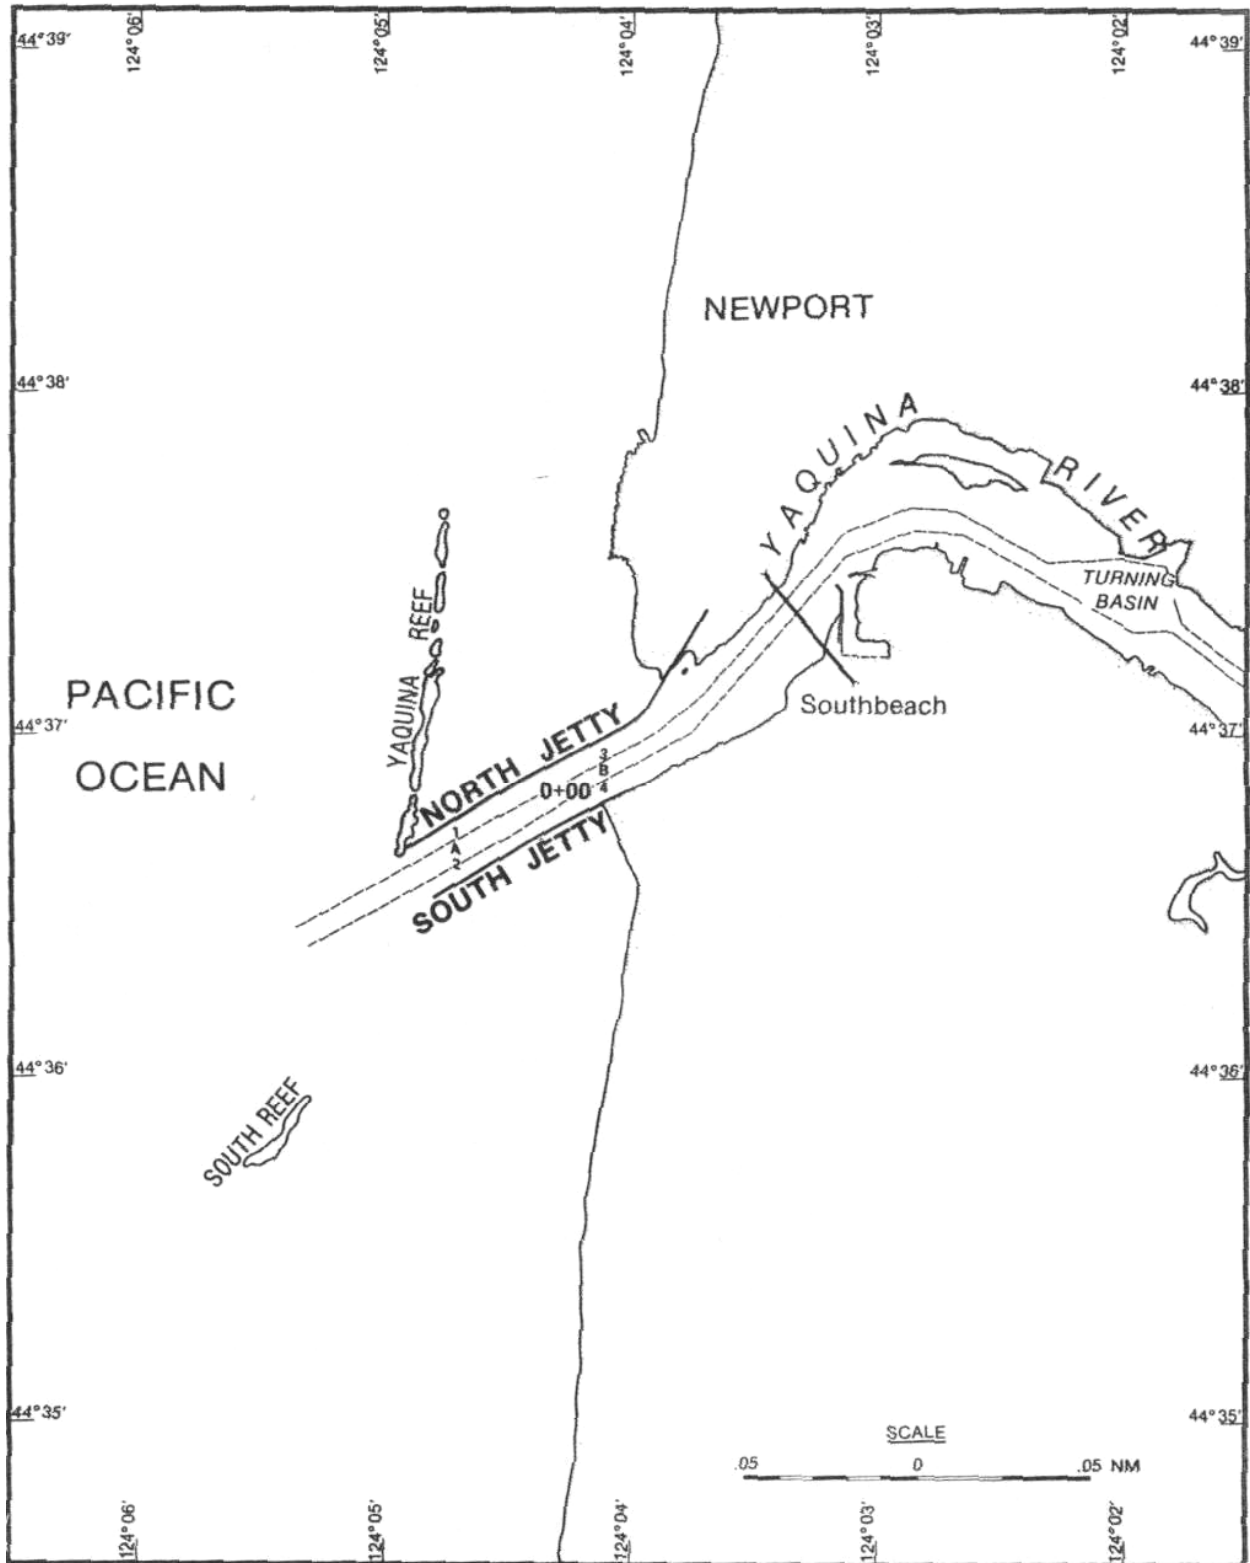
Figure 15. Yaquina Bay, Newport, OR (after Hughes et al. 1995)

Monitoring was conducted during the time period October 1988 – September 1994 to determine the likely cause for chronic damage to the Yaquina Bay north jetty. This monitoring also offered the potential for increasing understanding of failure mechanisms associated with rubble-mound structures and for improving methods of monitoring coastal structure performance in similar hostile wave and current environments (Hughes et al. 1995).

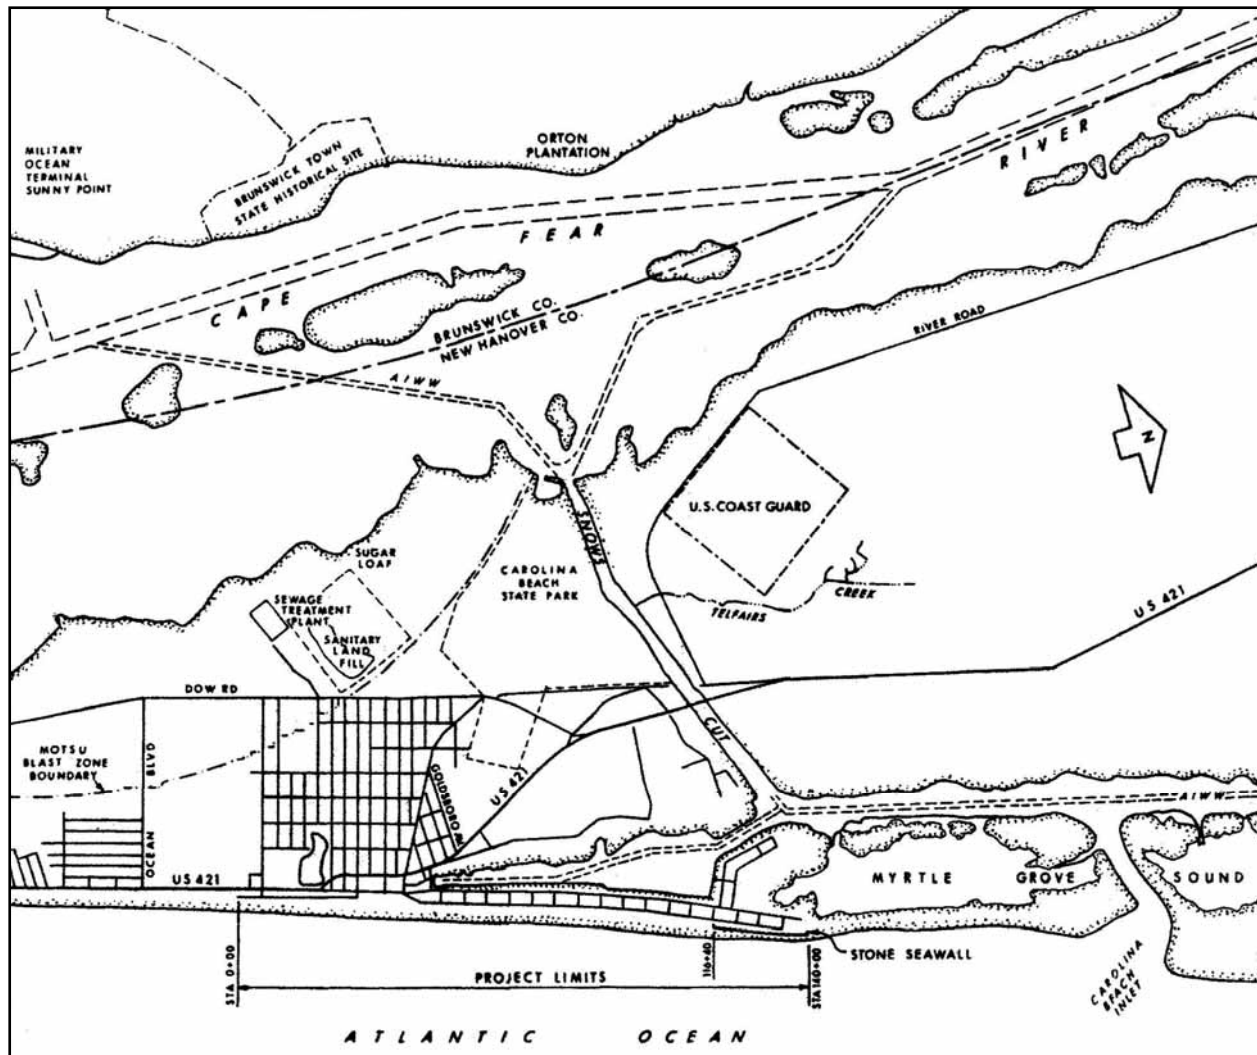
Figure 26. Carolina Beach, North Carolina (after Jarrett and Hemsley 1988)

- a.* The Carolina Beach project performed generally as expected, but experienced slightly higher volume losses than originally anticipated. Until the material in the construction berm along the southern 3,050 m (10,000 ft) of the project moves to the lower portion of the active profile, volume losses along this segment will probably continue to be high.

Eventually, the southern 3,050-m (10,000-ft) segment is expected to attain some degree of stability. Along the northern 1,220 m (4,000 ft), the sediment deficit caused by Carolina Beach Inlet remains a problem and will require a continuous renourishment program with materials obtained from the Carolina Beach Inlet sediment trap.

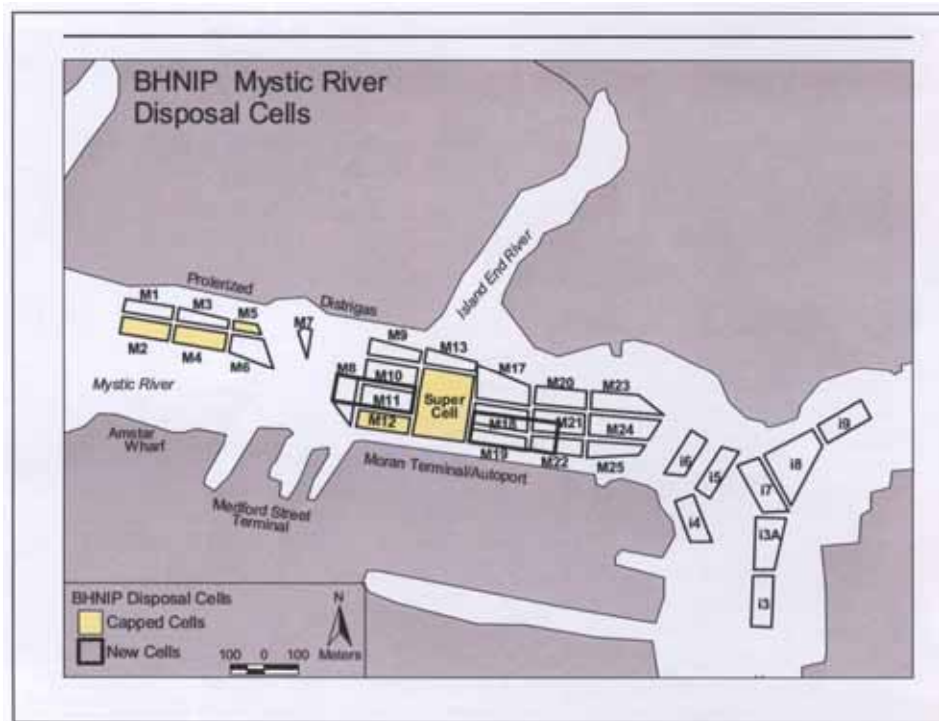
Figure 32. Confined Aquatic Disposal (CAD) cells being capped, Boston Harbor Navigation Improvement Project, Boston, MA (after Hales 2001)

- b. Grab samples and core samples indicated that: (1) natural cohesion and strength of the sediments were altered by the dredging process, resulting in sediments in the CAD cells that were unstable because of high water content and low shear strength; (2) excess pore water was released not only through the cap but also was vented through diapir structures that served to breach the caps in discrete areas; and (3) future projects should include an evaluation of the in situ strength of the material to be capped and the porosity and permeability of the CAD cell sediments.

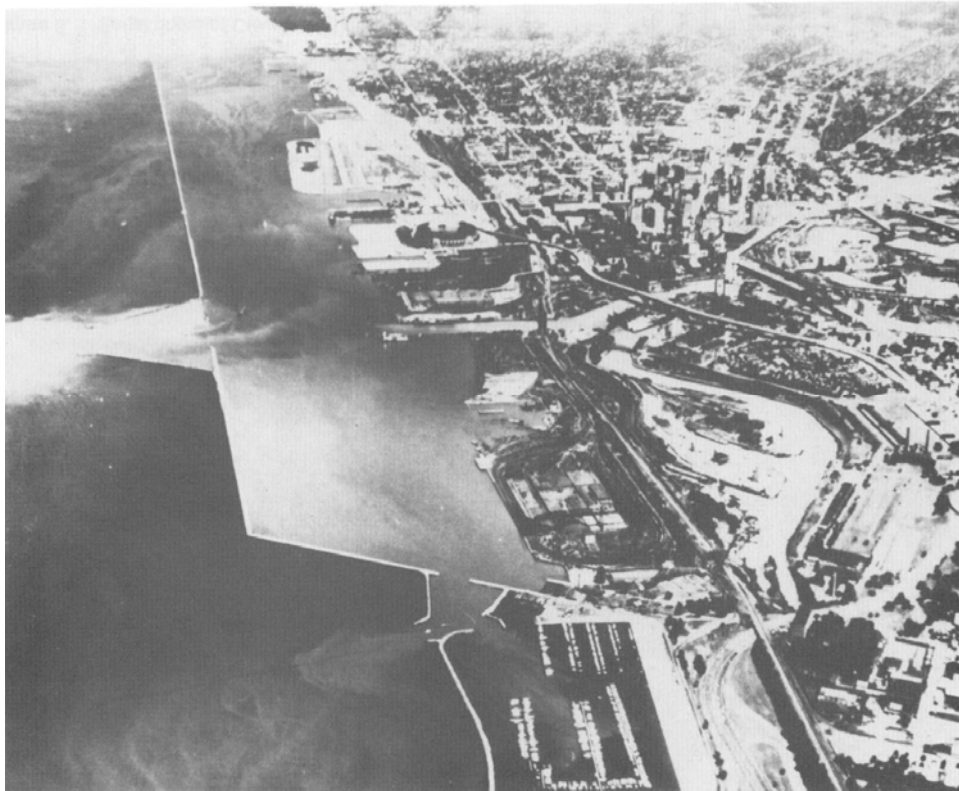
Figure 34. Cleveland Harbor, Cleveland, OH (after Pope et al. 1993)

Cleveland Harbor, Cleveland, OH (Figure 34), is located on the southern shore of Lake Erie 155 km (96 miles) east of Toledo, OH, and 285 km (176 miles) west of Buffalo, NY. Cleveland Harbor is situated at the mouth of the Cuyahoga River. It extends for a distance of about 7,620 m (25,000 ft) parallel to the shore. Cleveland Harbor is protected by a breakwater system which is over 9,150 m (30,000 ft) in total length. There are two entrances connecting the Harbor to Lake Erie. The west entrance is directly lakeward of the Cuyahoga River mouth, and the east entrance is at the open eastern end of the east breakwater. The east breakwater has had an extensive repair history, with storm damage occurring to cover stone especially on the lakeside.

- a. Although the 1,816-kg (2-ton) dolos-armored layer has deteriorated over the years, the breakwater continues to provide the required level of shore protection. Maintenance of the dolos cover has been on an as-needed basis. Repairs, including repositioning and/or the installation of additional armor units, are required after major storms.

- b. Wave reflection off the vertical concrete navigation light foundation at the breakwater head appears to contribute to the loss of armor units in that area. Dolos-armored units are very porous when a two-layer thickness is used. Wave energy transmits through the dolosse at Cleveland and reflects back upon them, apparently popping them out of place. Additional layers over reflective surfaces may be prudent for highly porous armor units.

- d. During the monitoring period, the 1,816-kg (2-ton) dolos cover continued to subside and lose elevation. Breakage of armor units also occurred throughout the monitoring period, but the rate of breakage appeared to decrease slightly toward the end of the monitoring period. Most breakage occurred along the waterline in the active wave zone. Little continued breakage was noted below the waterline during diving inspections.

- g. Side-scan sonar surveys proved to be a valuable means for obtaining qualitative documentation of the condition of the structure toe and the consistency of the cover layer slope. Combined with diving surveys, the underwater condition of the dolos cover was determined to have several flaws from original construction, including zones of no armor and areas where the toe appears unstable.

- i. The 2-D model study investigation, conducted subsequent to prototype construction, indicated that the dolos cover at Cleveland would be unstable for wave conditions in excess of 3.2 m (10.5 ft). When new breakwater cover concepts are being considered, a model investigation, incorporated as part of the design, would help in selecting the optimum cover unit. Proper design will minimize repair and rehabilitation costs during the life of these projects.

- h. Since dolos breakage can jeopardize the structure's integrity, dolosse should be designed for "no-rocking" criteria to minimize breakage resulting from movement. Consideration also should be given to reinforcement of dolosse in the active wave zone for a deepwater structure, since breakage appears to be concentrated in this area. In addition, dolosse should be placed over a stone underlayer rather than against a flat surface to prevent movement caused by wave reflection.

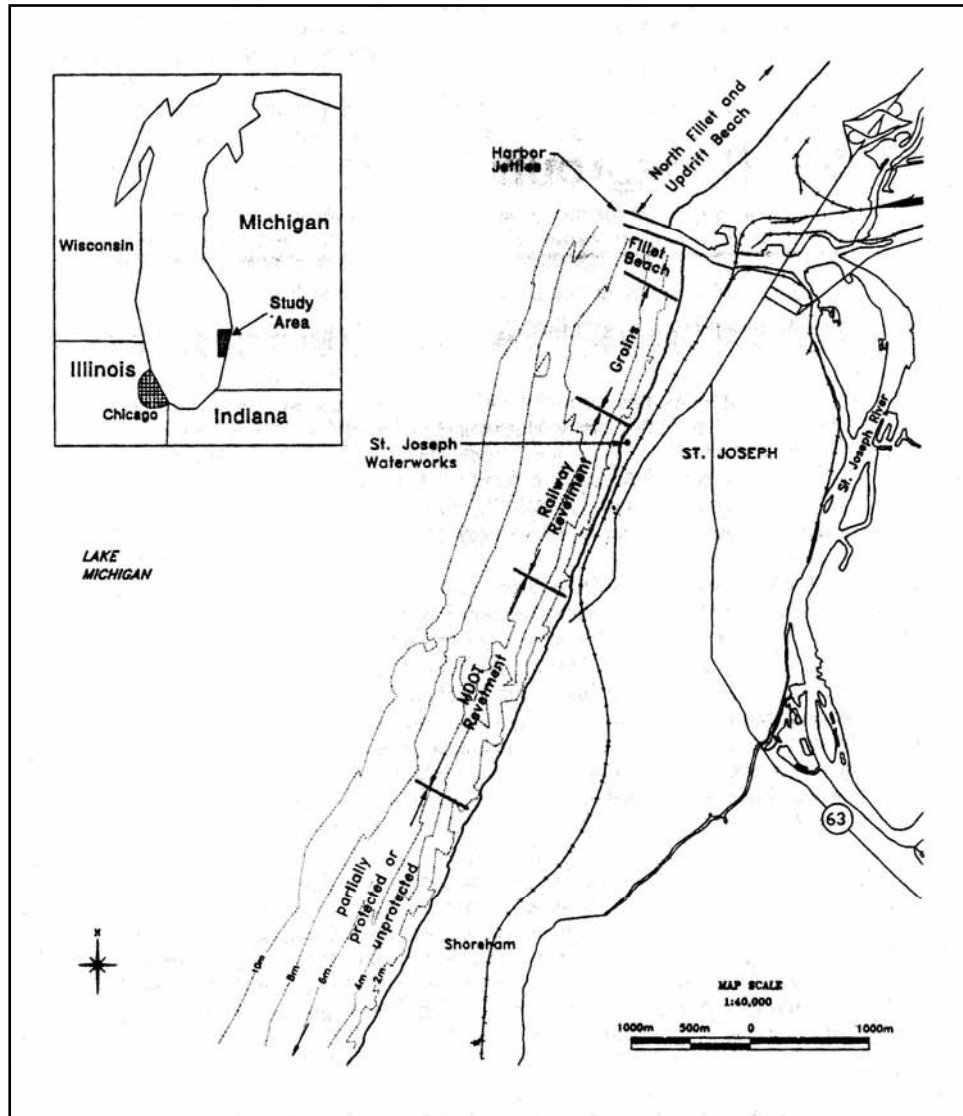
Figure 35. St. Joseph Beach, St. Joseph, MI (after Nairn et al. 1997)

St. Joseph Beach is located at St. Joseph, MI (Figure 35), on the southeastern side of Lake Michigan, about 42 km (26 miles) north of the Indiana/Michigan state line, and about 65 km (40 miles) west of Kalamazoo, MI.

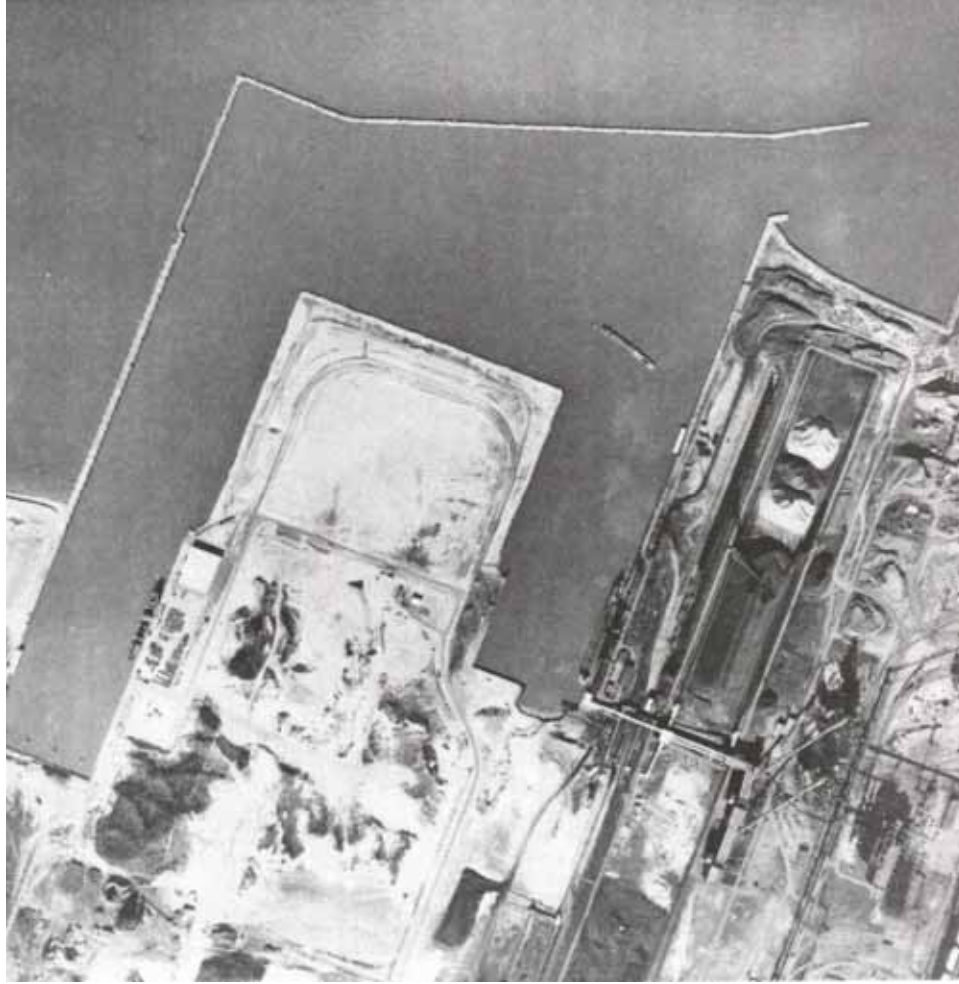
Figure 36. Burns Harbor, Indiana (after Bottin and Tibbetts 2000)

Burns Harbor, Indiana, is a man-made harbor located on the southern shoreline of Lake Michigan, approximately 32.2 km (20 miles) southeast of Chicago, IL (Figure 36). The Harbor was constructed primarily to facilitate shipping from the steel industry in northern Indiana. Breakwater construction was completed in September 1968, and harbor dredging was completed in August 1970.

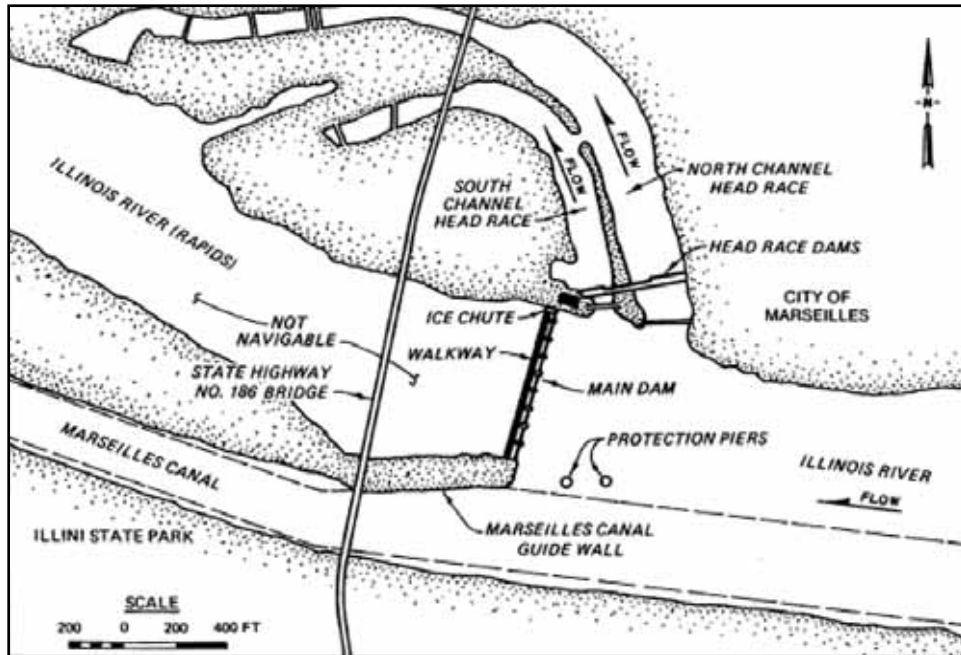
Figure 38. Marseilles Dam, Illinois River, IL (after Cooper et al. 2001)

Marseilles Dam is located near the upstream end of the Marseilles Canal at river mile 247.0 on the Illinois River, near the city of Marseilles, IL, approximately 9.6 km (6 miles) southeast of the city of Ottawa, La Salle County, and 104.6 km (65 miles) southwest of Chicago, IL (Figure 38). The main dam is a gated structure consisting of a 168.2-m- (552-ft-) wide section containing eight 18.3-m- (60-ft-) wide submersible tainter gates. Prior to the 1988-89 installation of a remote operating system, Marseilles Dam had to be attended 24 hr/day (amounting to four full-time operator positions) because the lock and the dam are 3.9 km (2.4 miles) apart, too distant to reasonably work both sites in a single shift. The existing operation of the gates at the dam is performed remotely from the lock operation room. The gate operations can also be operated in a manual-local mode of operation where all controls for gate operation are done from the machinery bridge above each gate.

Advantages of submersible gates are the capability of skimming loose ice with a minimum amount of flow and avoiding downstream scour often associated with large underflow gate openings at low tailwater. Also, submerged operation largely avoids the problem of freezing-in of side seals. Vibration of gates has been reported at some of the 33.5-m- (110-ft-) wide submergible gates on the

Ohio River. On some of these projects, a retrofit to a sharp-crested bottom seal eliminated the problem, but at other projects, the submerged mode of operation was discontinued.
